A metrological inspection method using micro-CT for the analysis of drilled holes in CFRP and titanium stacks

Abstract This paper demonstrates a novel method that combines X-ray computed tomography (CT) and image processing for investigating two materials with significantly different densities. CT is increasingly used in industrial applications of inspecting materials and defects. The limitations of the system and data reconstruction are continuously researched so as to improve the quality of the results. One of the most common issues in CT is beam hardening, frequently experienced in multi-material scanning. The materials examined to demonstrate the method are carbon fibre reinforced polymers (CFRP) and titanium alloy Ti6Al4V, often used in combination in industry to optimise the weight to strength ratio. The assembly of the materials is usually achieved by bolting and riveting, which requires drilling through the two materials together. The machining of these materials is difficult due to their higher specific properties and as a result tool wear is always an issue. CFRPs properties depend on the nature, orientation and bond of the fibres and as a result drilling affects their s

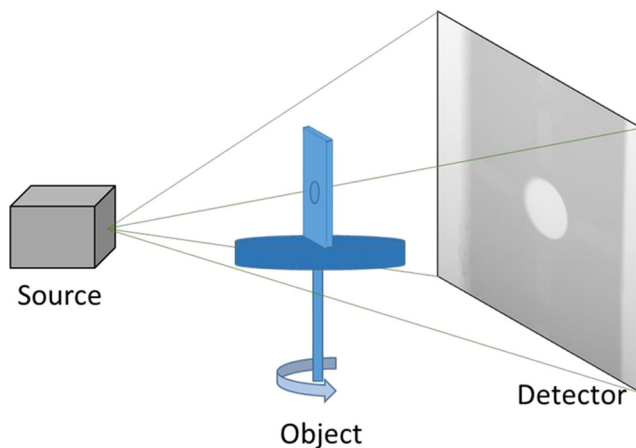
Fig. 1 The grey value of each pixel demonstrates the attenuation level of x-rays from matter

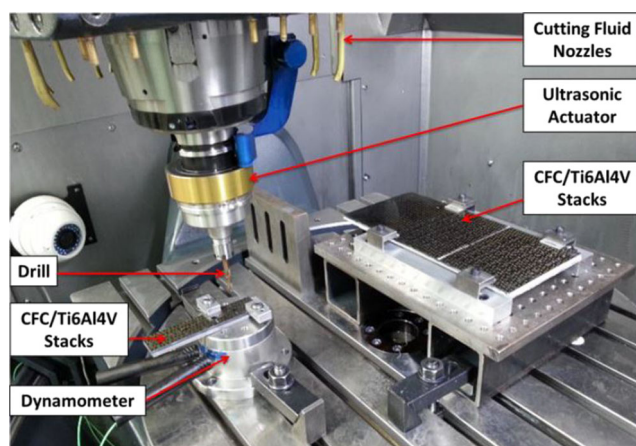
Fig. 2 Experimental drilling set-up of conventional and ultrasonic drilling

Both machining processes, CD and UAD, were performed on CFRP/Ti6Al4V stacks with the same machine, Ultrasonic 65 monoBLOCK, DMG with an ultrasonic actuator built into the tool holder, as shown in Fig. 2. The two materials were joined together with Hysol 9492 prior to the machining. The thickness of the different materials was 4 mm. The cutting speed and feed rate were constant at

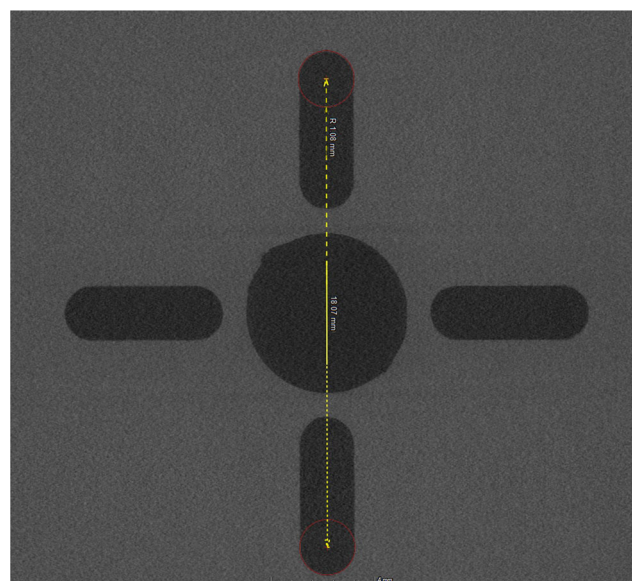
Fig. 3 Voxel rescaling according to CMM measurements. The centre to centre distance of the prescribed circles shown are scaled to the actual center to center distance measured by optical CMM

Four slots were produced prior to the drilling of each hole so as to mark the centre of the hole and the orientation of the part during the drilling, as shown in Fig. 3, and they were used for voxel rescaling during the image processing. The tool used for the production of the slots was a 2-mm-diameter Q-coat tungsten carbide slot drill with cutting speed 18.833 m/s, cross feed 0.042 m/s and depth feed 0.002 m/s. Their depth is 0.7 mm and length 8 mm.

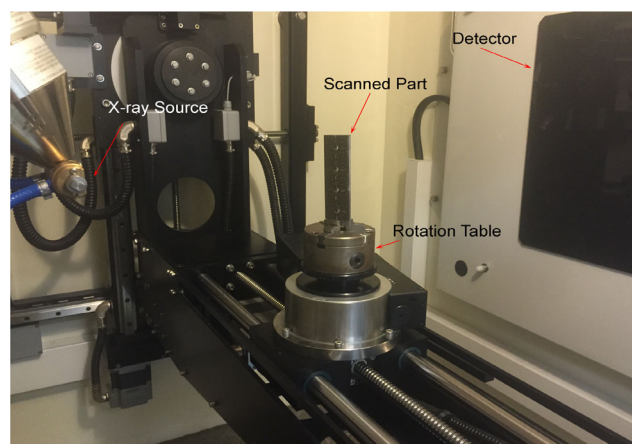
Fig. 4 X-ray set-up. In order to achieve maximum resolution, the part needs to be placed as close to the X-ray source as possible while keeping the part in the field of view

CT scanning depends on a series of variables that are selected based on the scanned material, the capabilities of the CT system and the required resolution. In order to achieve optimum results that can be used for a metrological investigation, VDI/VDE 2630 Part 1.4 guidelines were followed. The CT scanning set-up is shown in Fig. 4.

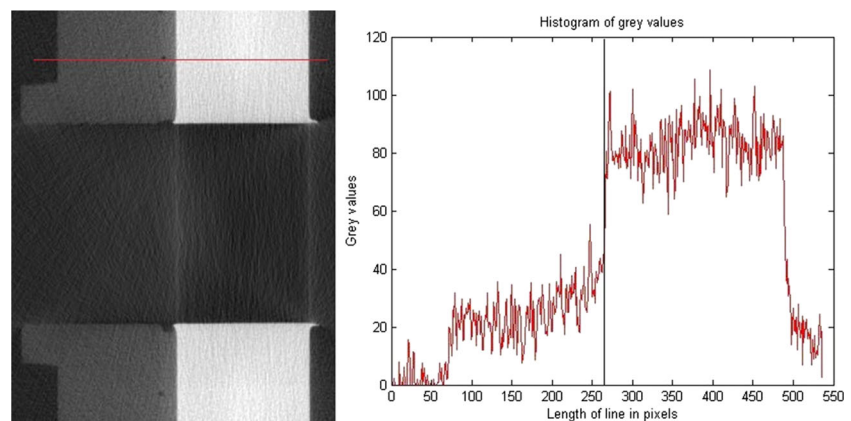
Fig. 5 The histogram demonstrates the irregularities of grey values at the red line in the 2D slice. The black line in the histogram shows the point where the material change

The combination of the two materials with distinctly different atomic masses cause one of the most common CT artefacts, which is beam hardening. Figure 5 demonstrates the effect of beam hardening and noise caused by the scanning of the two materials with the histogram providing the amount of grey values in the length of the red line. The black line in the histogram demonstrates the point where the materials intersect. The areas that are affected by these artefacts are around the titanium alloy. Prior to the reconstruction of the 2D images, a beam hardening reduction algorithm with offset was used to minimise the effect of the artefacts in the model [49].

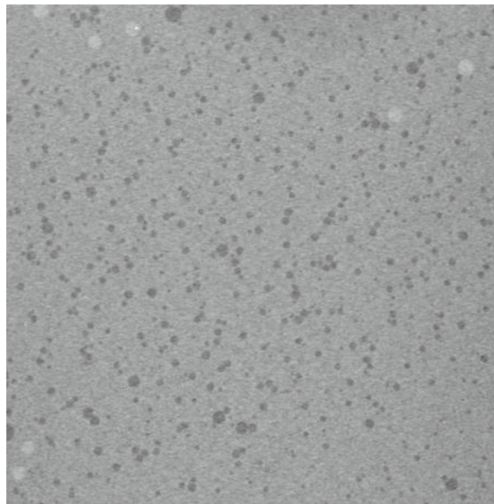
Fig. 6 Examination of the joint show extreme porosity. Pores are represented as *black* and glass particles as *white*

Initially, the joining of the two materials was visually examined prior to the drilling, as shown in Fig. 6. The joining of the materials was achieved by Hysol 9492 and includes glass particles with 0.3 mm diameter to ensure homogenous thickness. The results show significant porosity in the joint and the glass particles are easily identifiable from their higher density in comparison to the surrounding material. This joining was intended to bond the two materials together after the drilling for the CT investigation since no other fastening method is used.

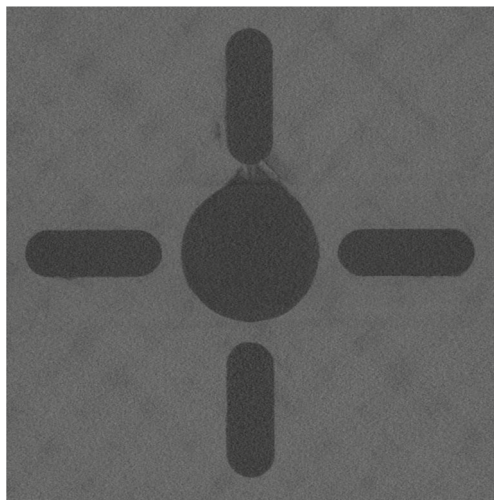
Fig. 7 The slots are close to the hole and may have affected the entrance delamination

Each hole was also visually inspected prior to the image analysis to identify any abnormalities. Concerns were raised because it is believed that the close proximity of the slots to hole could have affected the entrance delamination as shown in Fig. 7, subsequent analysis negates the entrance delamination that may have been compromised, although this effect is well known and previously quantified [22, 23, 28].

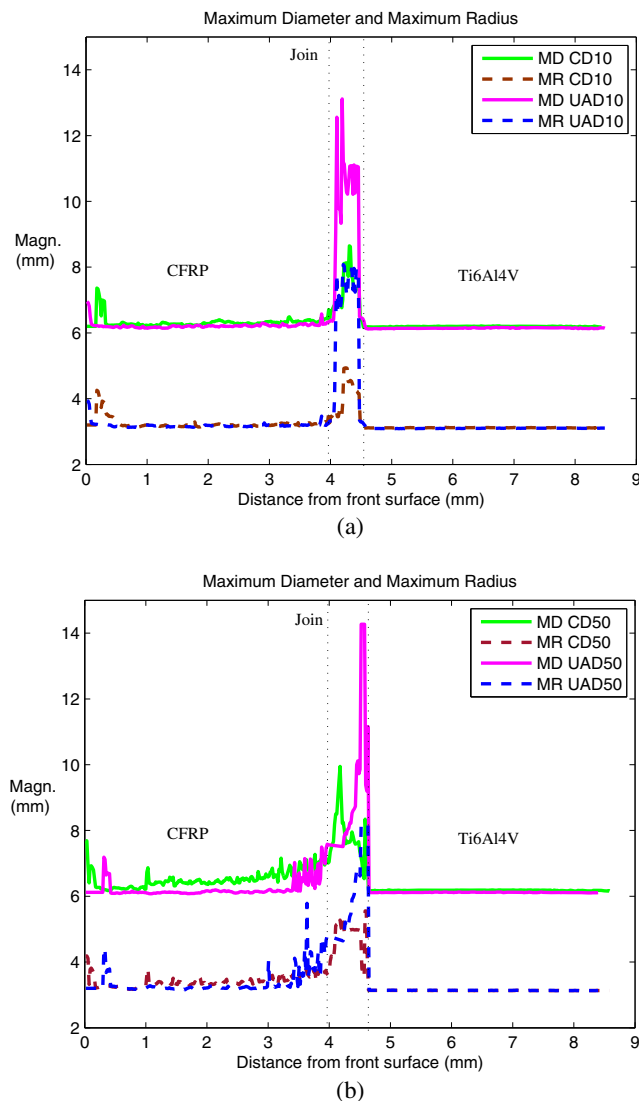
Fig. 8 Maximum diameter and maximum radius per slide. The different sections of the hole are identified as CFRP, Join and Ti6Al4V. Results for (a) 10th drilled hole and (b) 50th drilled hole

Ti6Al4V. The greatest difference in the results are in the joins that are affected by severe porosity. The results of the maximum diameter and radius of the first and last inspected holes are shown in Fig. 8a, b. Hole nos. 10 and 50 for each technique demonstrate the difference of distribution that is located in the joins due to the porosity and discontinuities of the joining material. In order to examine the results of the two materials better, the following figures do not include the values from the area of the joins.

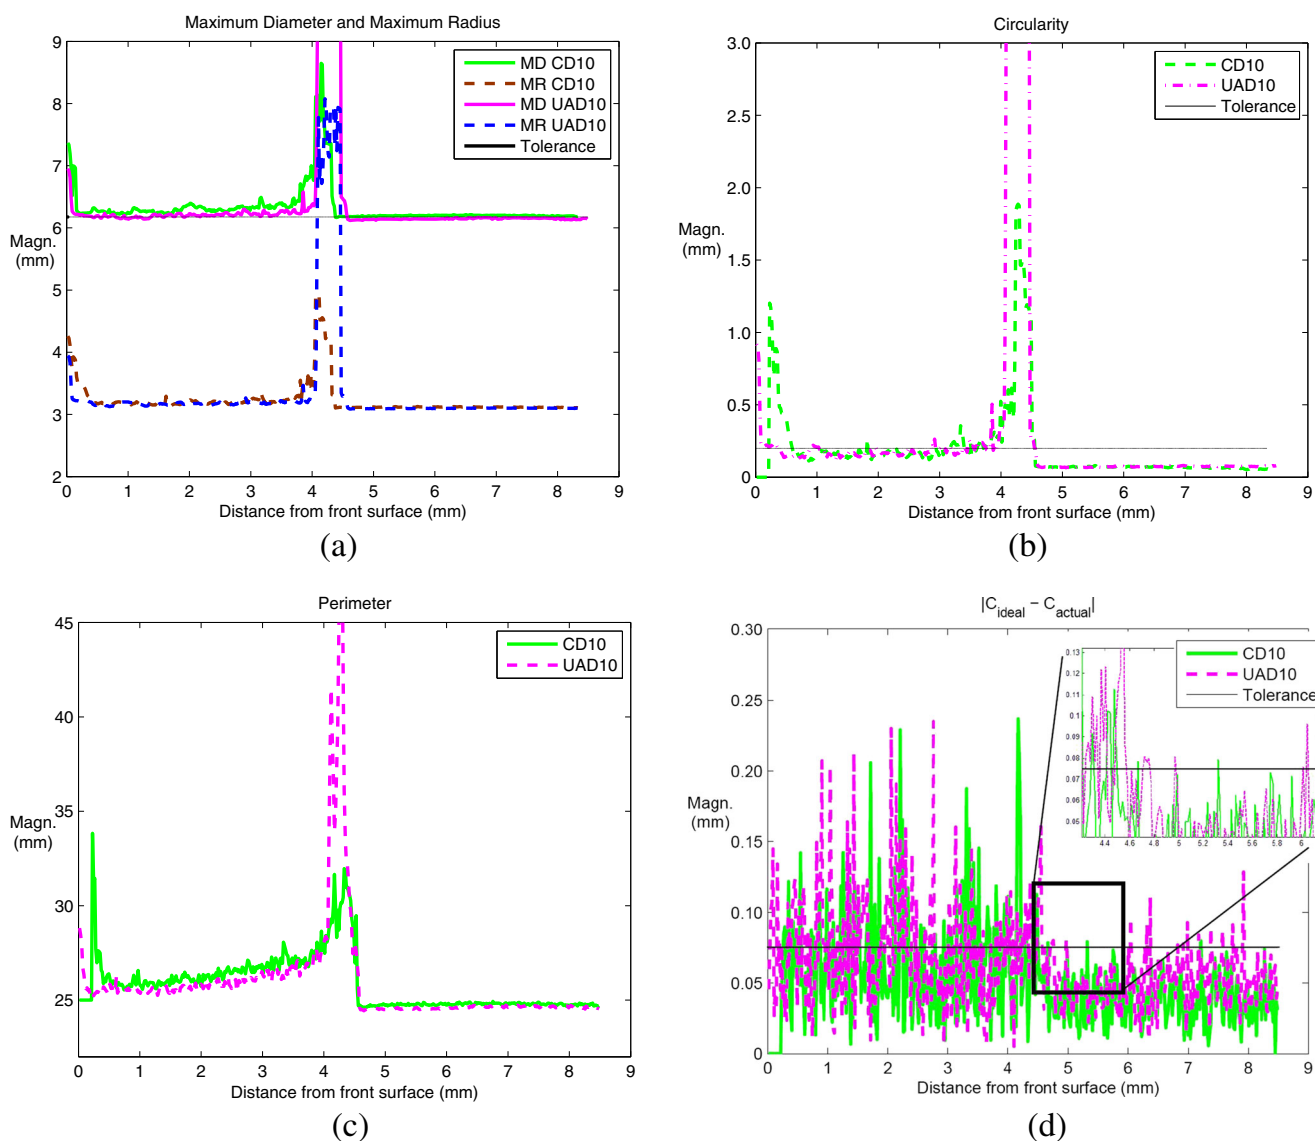
Fig. 9 The results of the first holes for both CD and UAD of the 10th holes. The results shown are per slice and the entrance surface is located at 0 mm and exit surface at 8.4 mm. Tolerances are given for diameter, circularity and positioning. Panel **a** shows the maximum

diameter and radius, **b** shows the circularity results, **c** show the results for the perimeters and **(d)** shows the positioning with a zoom in area to demonstrating the difference between the two materials

The results of the first pair of holes, CD10 and UAD10, shown in Fig. 9a indicate that the maximum radius and diameter of both materials are more consistent and closer to tolerance with UAD. The maximum values of maximum diameter and radius for CFRP are 6.432 and 3.365 mm for CD and 6.293 and 3.209 mm for UAD, ignoring the entrance delamination and the joining session, the maximum diameter for the Ti6Al4V is 6.204 mm for CD and 6.163 mm for UAD, the maximum radius of Ti6Al4V is stable and does not exceed 3.125 mm. Even so, both holes would have failed inspection since the CFRP part of the holes exceed the required tolerance of 6.195 mm diameter. Figure 9b shows the results of circularity. Overall, the results are similar for the two drilling methods with the Ti6Al4V circularity varied around 0.055 mm and the CFRP circularity varied just below the tolerance of 0.200 mm except the few random peaks reaching 0.504 mm for UAD and 0.207 mm for CD. The maximum value of circularity for the CFRP is 0.273 mm for CD and 0.0239 mm for UAD. The circularity of Ti6Al4V is stable for both drilling methods and it does not exceed 0.080 mm. Perimeter results of the first holes, CD and UAD 10, also indicate that UAD provides slightly more stable results, as shown in Fig. 9c. The difference between the two techniques is not significant and show that the perimeter of the UAD hole does not exceed 26.149 mm for CFRP and 24.699 mm for Ti6Al4V while the results of the CD hole demonstrate that the perimeter reaches 27.871 mm for the CFRP and 24.899 mm for the Ti6Al4V. The positioning of the holes, shown in Fig. 9d, fail to meet the tolerance target of 0.075 mm and reaches 0.237 mm for CD and 0.241 mm for UAD. The results of both drilling methods give similar readings and CFRP positioning is worse than the positioning of Ti6Al4V.

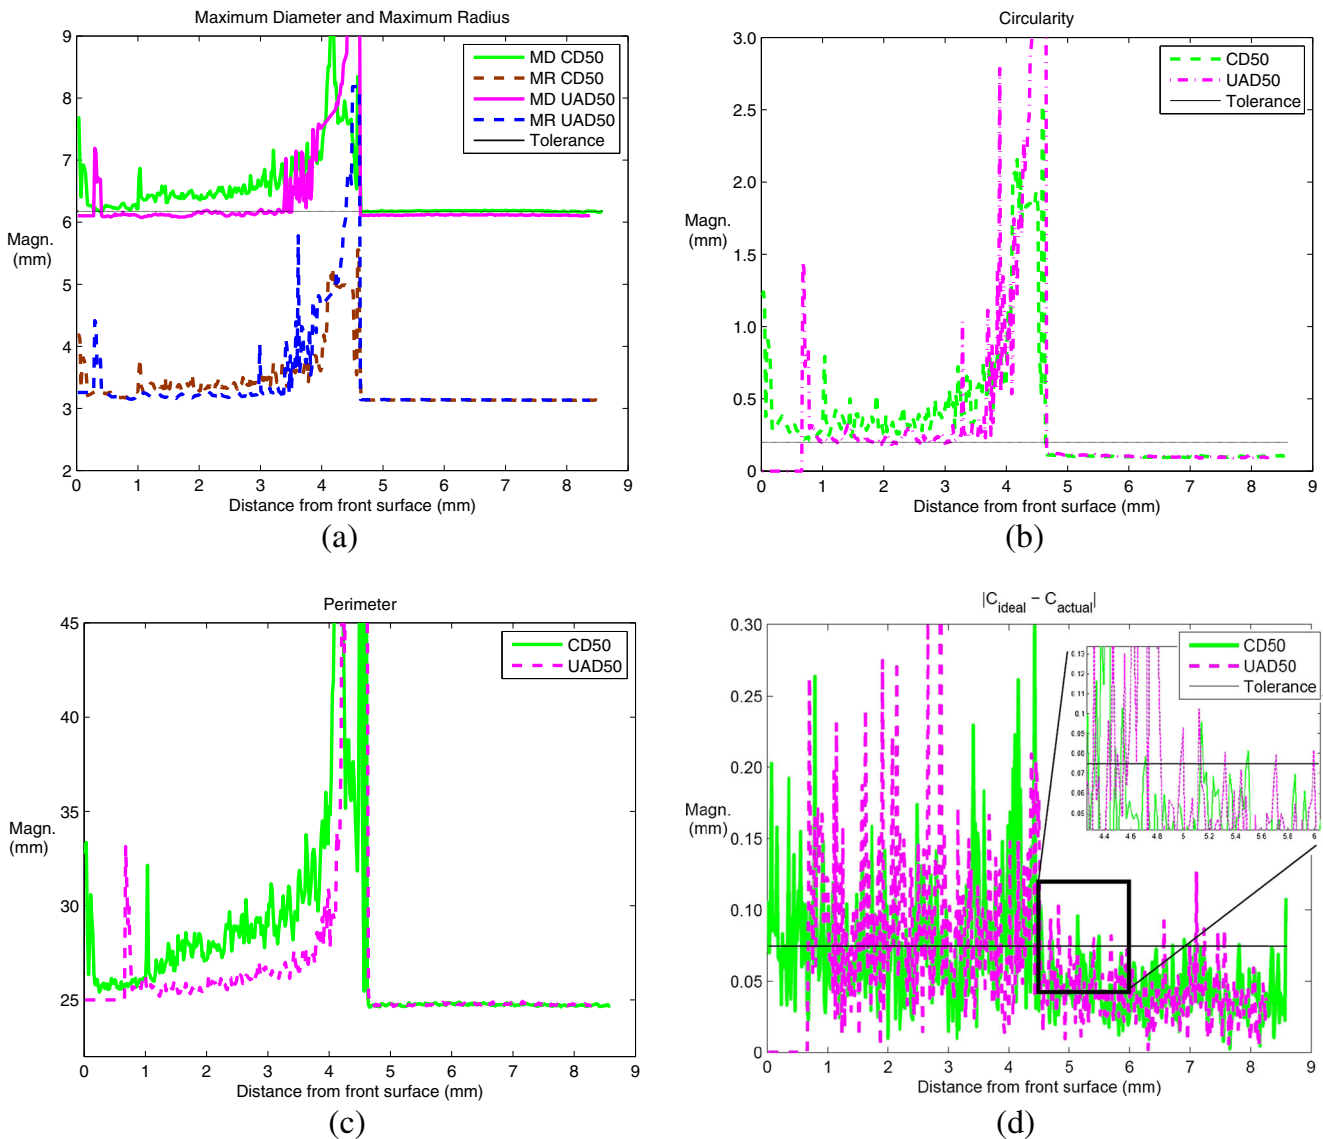
Fig. 10 The results of the last holes for both CD and UAD of the 50th holes. The results shown are per slice and the entrance surface is located at 0 mm and exit surface at 8.4 mm. Tolerances are given for diameter, circularity and positioning. Panel **a** shows

maximum diameter and radius, **b** shows the circularity results, **c** show the results for the perimeters and **(d)** shows the positioning with a zoom in area to demonstrating the difference between the two materials

The results of both materials worsen with tool wear, especially for CD. Figure 10 shows the maximum radius, circularity, perimeter and positioning differentiate the results of the two drilling methods, more for CFRP while the results are getting more similar for the titanium alloy. Figure 10a shows that that UDA hole provides better results since both CFRP and Ti6Al4V are below the tolerance with only a

few high values exceeding for the CFRP and indicate exit delamination with a radius reaching 5.784 mm. Ti6Al4V radius is in the steady range of 3.130 mm. The circularity results shown in Fig. 10b show CFRP results slightly failing to meet the tolerance with few worse exceptions close to the entrance and exit CFRP surfaces reaching 1.407 mm. Ti6Al4V results show a better picture for both drilling techniques with the circularity stable close to 0.098 mm. The

perimeter results, Fig. 10c, similarly show stable results for Ti6Al4V for both drilling methods while the perimeter of CFRP reaches 33.141 mm close to the entrance surface for both techniques. The circularity and perimeter results shown in Fig. 10b, c show that tool wear affects CD more than UAD. The results of positioning of the holes, Fig. 10d, show that tool wear affects the position of both CD and UAD, and reaching 0.3 mm for CFRP.
